Report for
Energy Efficiency and Conservation Authority

**INVESTIGATING QUALITY OF INSULATION IN NEW
BUILD RESIDENTIAL HOMES**

Report Author: Sarah Symon
Manager
Realsure Ltd

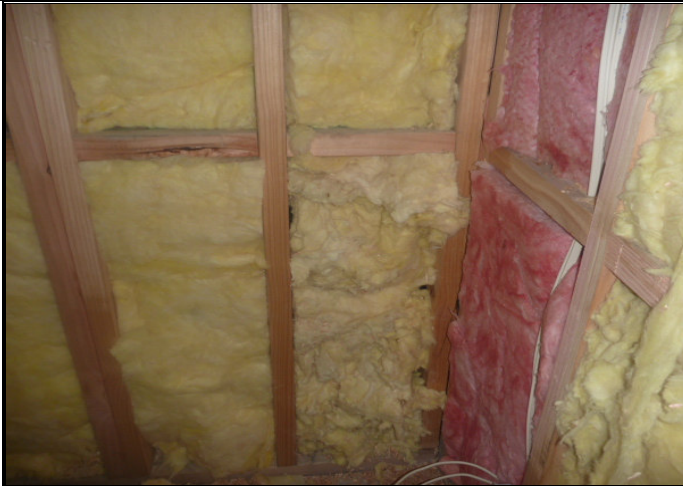
Damaged	
<p>The Auditors looked for whether any of the insulation material installed was damaged. It was found that 24% of ceiling installations and 13% of wall installations had damaged insulation. Of those defects, 85% of the ceiling defects and 80% of the wall defects were rated as minor.</p>

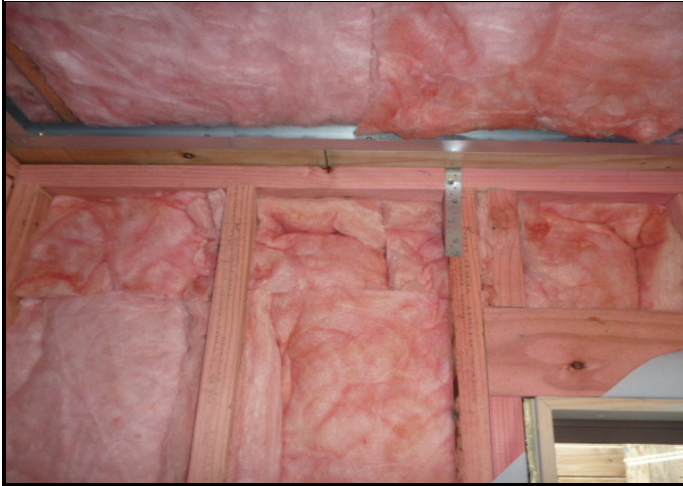
Folds	
<p>The Auditors looked for whether any of the insulation material installed was subject to folds. It was found that 55% of ceiling installations and 67% of wall installations had folds in the insulation. Of those defects, 60% of the ceiling defects and 54% of the wall defects were rated as minor.</p>

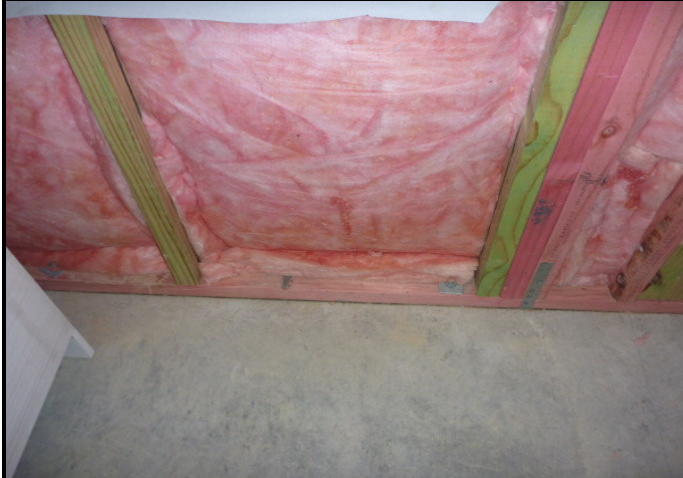
Tucks	
<p>The Auditors looked for whether any of the insulation material installed was subject to tucks. It was found that 55% of ceiling installations and 85% of wall installations had tucks in the insulation. Of those defects, 64% of the ceiling defects were rated as minor. However, 70% of the wall defects were rated as medium to major</p>

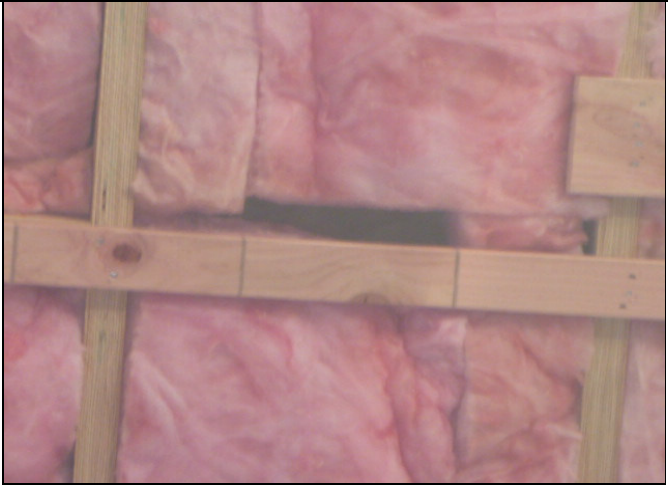
Gaps	
<p>The Auditors looked for whether any of the insulation material installed was subject to gaps. It was found that 91% of ceiling installations, 67% of underfloor installations, and 95% of wall installations had gaps in the insulation. Of those defects, 52% of the ceiling defects and 100% of the underfloor defects were rated as minor. However, 51% of the wall defects were rated as medium to major</p>

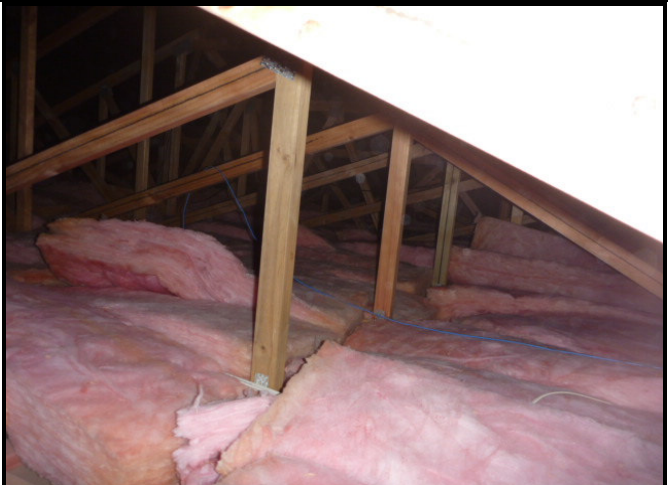
Overlaps	
<p>The Auditors looked for whether any of the insulation material installed was subject to overlaps. It was found that 56% of ceiling installations had overlaps in the insulation. Of those defects, 55% were rated as minor.</p>

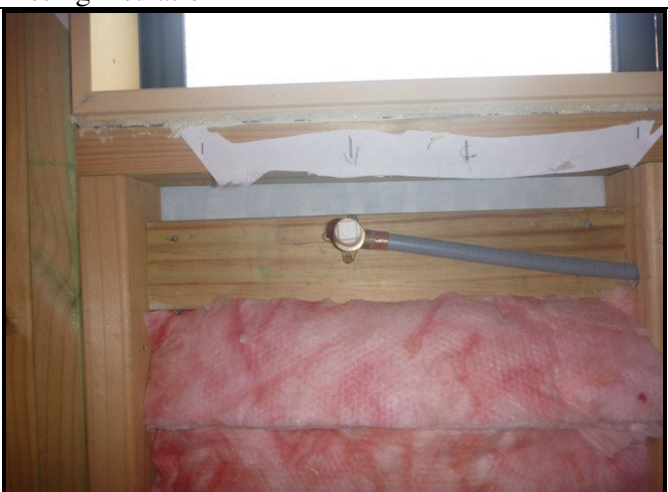
Missing insulation	
<p>The Auditors looked for whether there was any missing insulation. It was found that 36% of ceiling installations and 77% of wall installations had missing insulation. Of those defects, 55% of the ceiling defects and 67% of the wall defects were rated as minor.</p>

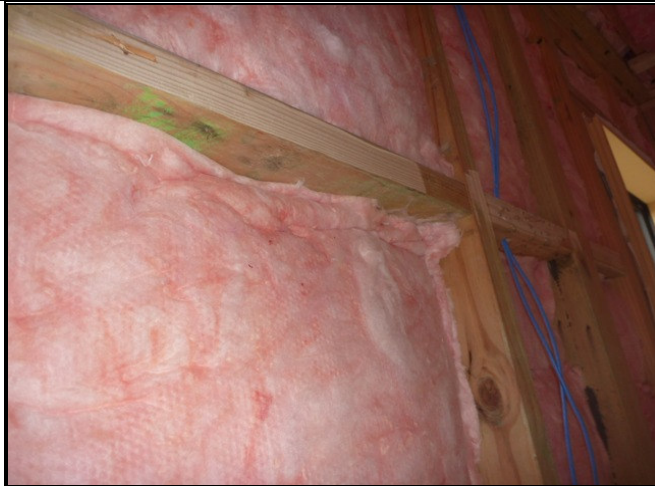
Compressed by installer

The Auditors looked for whether any of the insulation material installed was compressed, as a result of the installer. It was found that 45% of ceiling installations, 33% of underfloor installations, and **87% of wall installations had compressed insulation, due to the installer.** Of those defects, 64% of the ceiling defects and 56% of the wall defects were rated as minor.

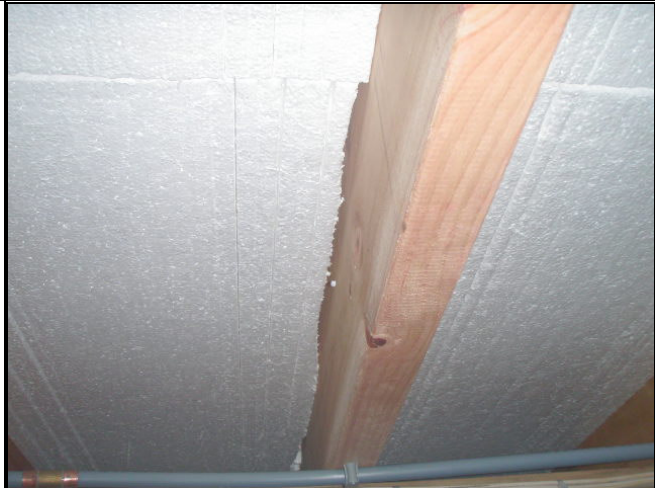
Fixings not correct

The Auditors looked for whether any of the insulation material was incorrectly fixed. It was found that 4% (2 audits) of ceiling installations and **67% (2 audits) of underfloor installations had been incorrectly fixed.** Of those defects, **100% of the ceiling and underfloor defects were rated as major.**

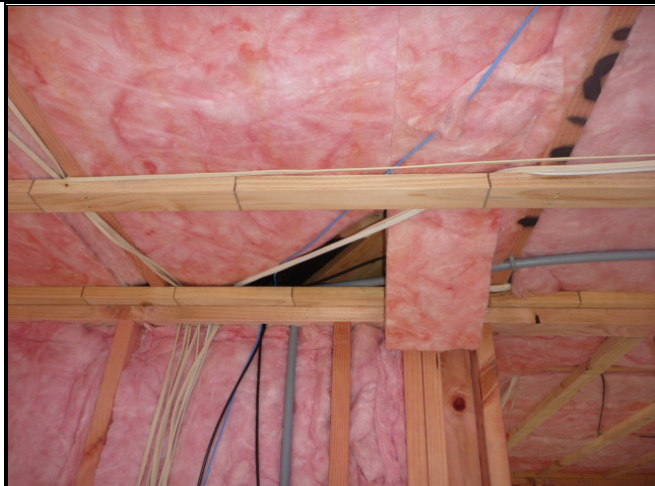
Temporary supports not in place

The Auditors looked for whether any of the insulation material installed had temporary supports to keep the insulation in place, where required. It was found that 44% of ceiling installations and 13% of wall installations did not have temporary supports in place. Of those defects, 75% of ceiling defects were rated as medium to major. 60% of the wall defects were rated as minor.

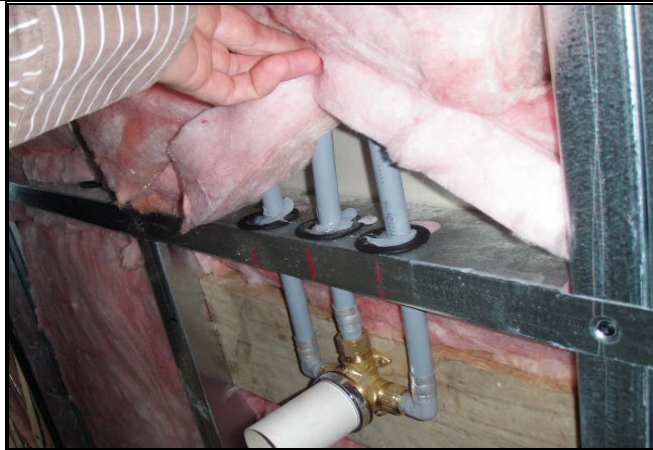
Insulation between plumbing and outside wall (Should)

The Auditors looked for whether the insulation material had been installed between any plumbing and the outside wall. It was found that 31% of wall installations did not have insulation fitted between the plumbing and wall. Of that 31%, 58% were rated as minor.

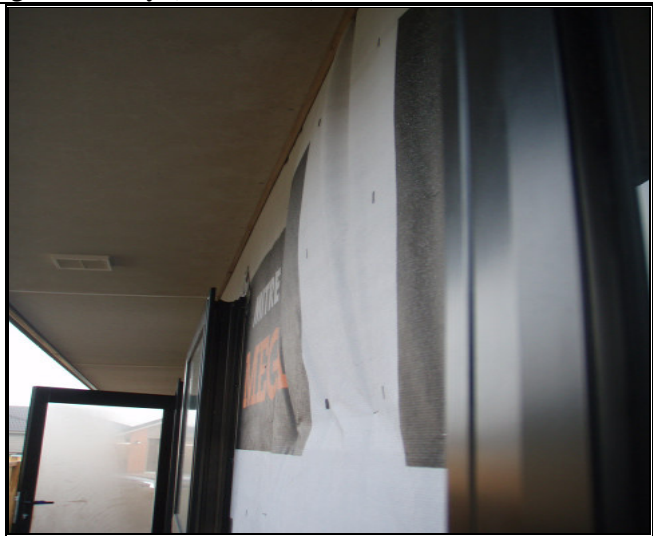
Protruding into cavity (Should not)

The Auditors looked for whether the insulation material could be seen to be protruding into the cladding cavity. It was found that 1 property audited (3%) was subject to this defect and was rated as minor. This was identified because the brick veneer had not been installed.

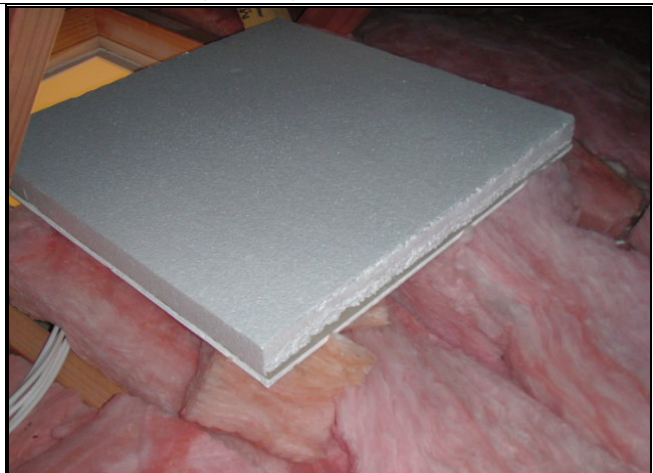
Access hatch insulated (Should)

The Auditors looked for whether the insulation material was fitted to the access hatch. It was found that **22 of 23 access hatches installed were not insulated.**

The Photo shows the insulated hatch.

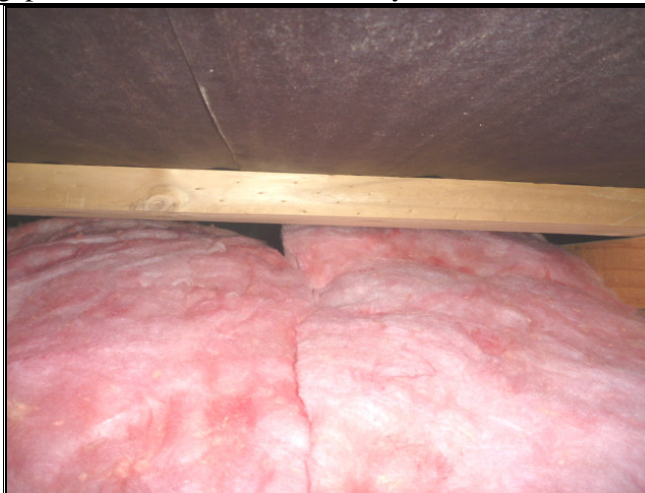
Lack of 25 mm gap to under side of roof underlay

The Auditors looked for whether the insulation material had been installed with a 25 mm gap to the underside of the roof underlay. It was found that **64% of ceiling installations failed to achieve the clearance.** Of those defects, **94% were rated as medium to major.**

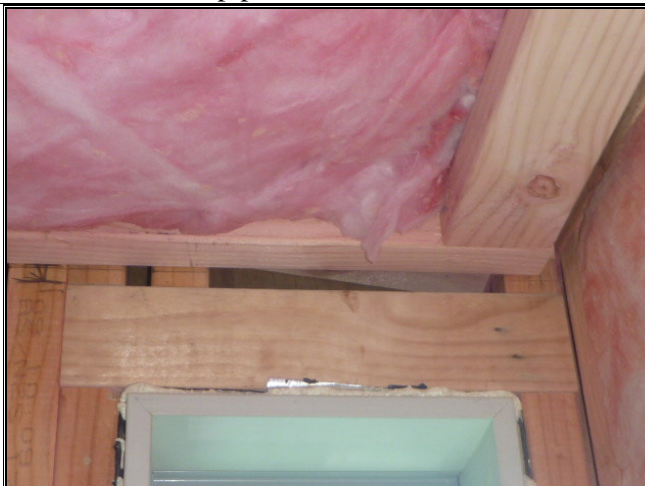
Insulation to middle of top plate

The Auditors looked for whether the insulation material had been installed to the middle of the top plate. It was found that **60% of ceiling installations failed to achieve the clearance.** Of those defects, **94% were rated as medium to major.** The photo shows insulation within the ceiling framing, rather than over the top plate. It also shows an example of missing insulation behind a window lintel, due to design.

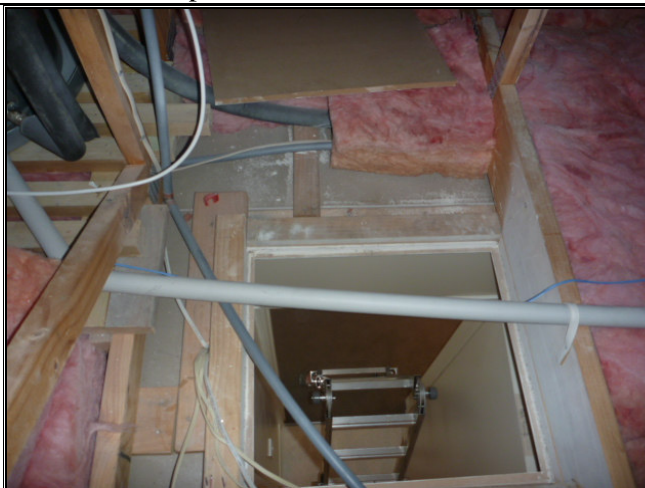
Insulation not complete

The Auditors looked for whether the insulation installations were indeed complete. It was found that **5% of ceiling installations and 10% of wall installations were found to be incomplete,** although they had been deemed completed. Of those defects, **100% of the ceiling defects were rated as minor.** **94% of the wall defects were rated as medium to major.**

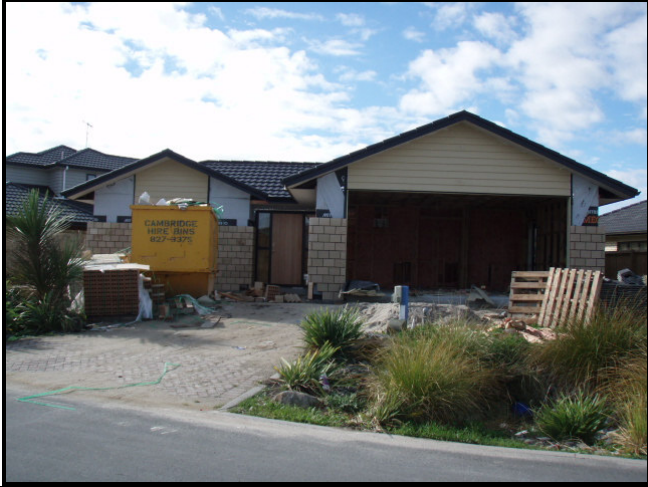
Building envelope complete (Should)	
<p>The Auditors looked for whether the building envelope appeared to have been completed, prior to the insulation material being installed. It was found that 7% of ceiling installations and 51% of wall installations were undertaken, while the building envelope had not been completed. Of those defects, 50% of the ceiling defects were rated as medium. 58% of the wall defects were rated as minor.</p>

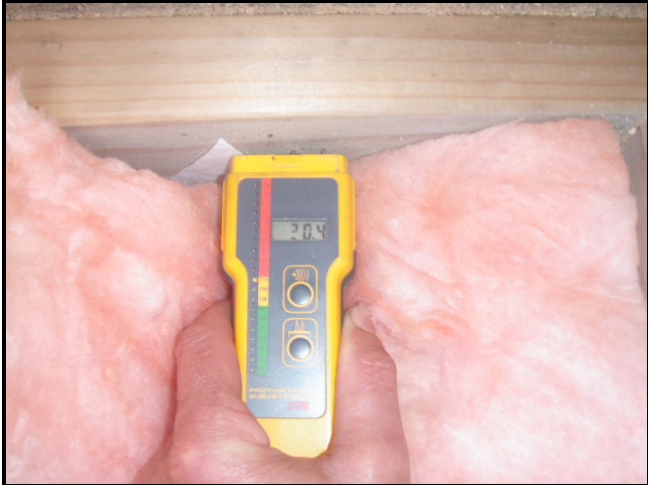
Moisture levels under 16% (Should)	
<p>The Auditors looked for whether the moisture levels of the timber framing were less than 16%, prior to the insulation material being installed. It was found that 4% of ceiling installations and 28% of wall installations were undertaken, while the moisture levels were greater than 16%. Of those defects, 50% of the ceiling defects and 63% of the wall defects were rated as medium to major.</p>

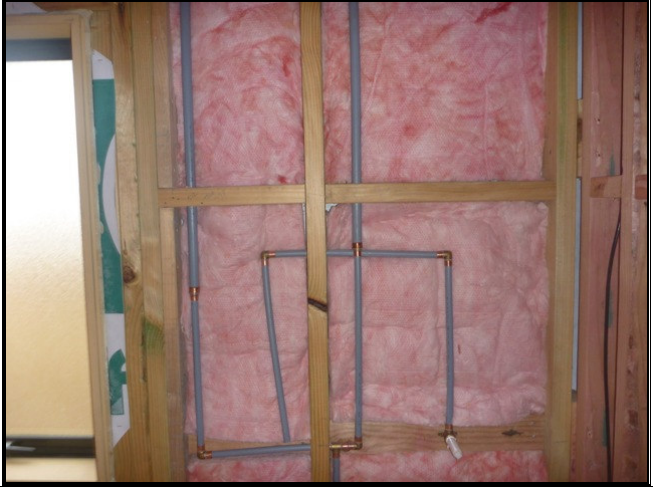
Compressed by plumbing	
<p>The Auditors looked for whether any of the insulation material installed was compressed, as a result of the plumbing. It was found that 47% of ceiling installations and 82% of wall installations had compressed insulation, due to plumbing. Of those defects, 77% of the ceiling defects and 69% of the wall defects were rated as minor.</p>

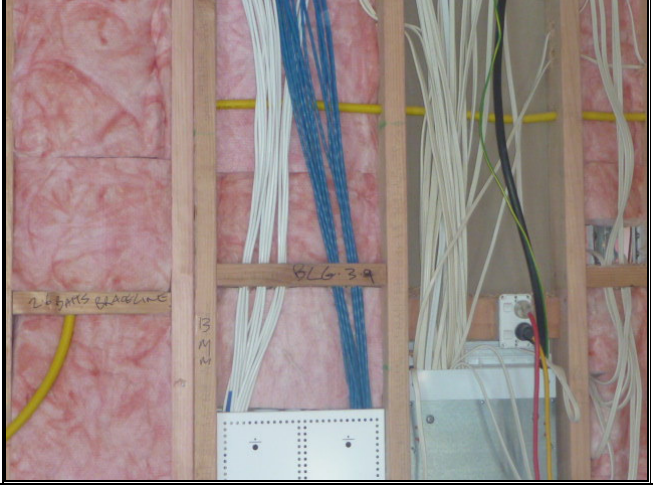
A photograph showing a wall cavity with pink insulation. Blue and copper plumbing pipes are installed, and the insulation is visibly compressed and displaced by the pipes.
Compressed by electrical wiring	
<p>The Auditors looked for whether any of the insulation material installed was compressed, as a result of electrical wiring. It was found that 53% of ceiling installations and 85% of wall installations had compressed insulation, due to electrical wiring. Of those defects, 83% of the ceiling defects and 55% of the wall defects were rated as minor.</p>

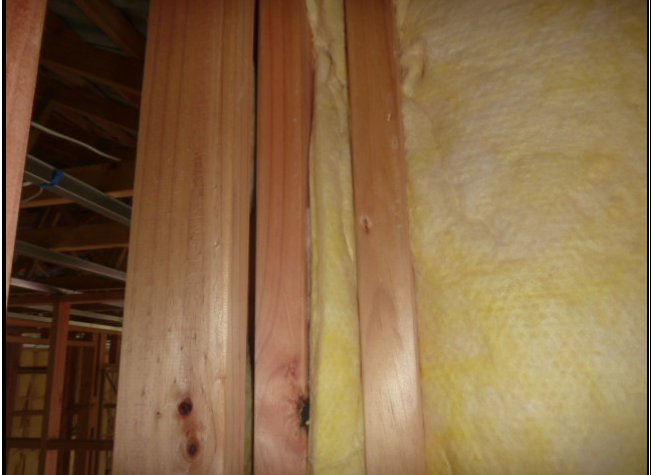
Compressed by insufficient space	
<p>The Auditors looked for whether any of the insulation material installed was compressed, as a result of the design not allowing for sufficient space for the insulation. It was found that 47% of ceiling installations and 85% of wall installations had compressed insulation, due to insufficient space. Of those defects, 61% of the ceiling defects were rated as medium to major. 73% of the wall installations were rated as minor.</p>

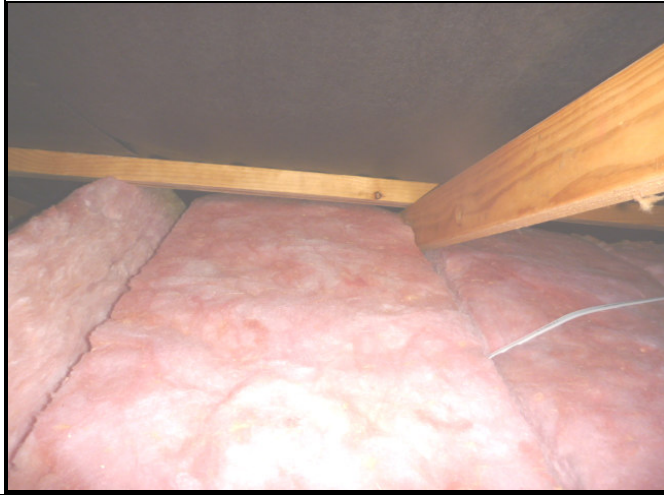
25mm Gap to underlay not achieved due to design

The Auditors looked for whether the insulation material was able to be installed with a 25 mm gap to the underside of the roof underlay. It was found that **64% of ceiling installations failed to achieve the clearance**. Of those defects, **94% were rated as medium to major**.

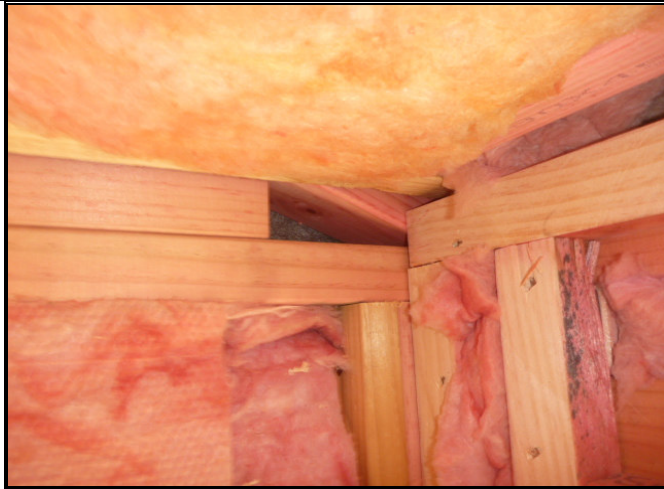
Insulation to middle of top plate

The Auditors looked for whether the insulation material was able to be installed to the middle of the top plate. It was found that **60% of ceiling installations failed to achieve the clearance**. Of those defects, **94% were rated as medium to major**.

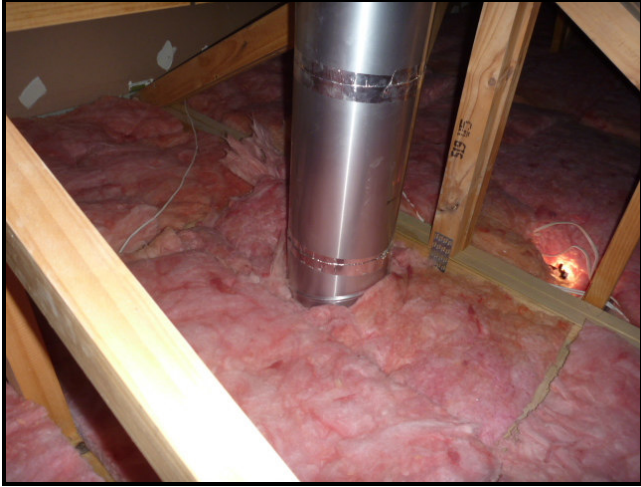
Downlights covered	
<p>The Auditors looked for whether the insulation material had been installed over recessed downlights. It was found that 8 of 17 audits with downlights installed were found to be covered. Of those defects, 80% were rated as medium to major.</p> <p>The bright light on the right side of the photo shows a recessed downlight covered by insulation. It also shows an example of insufficient clearance of the insulation from the metal flue.</p>

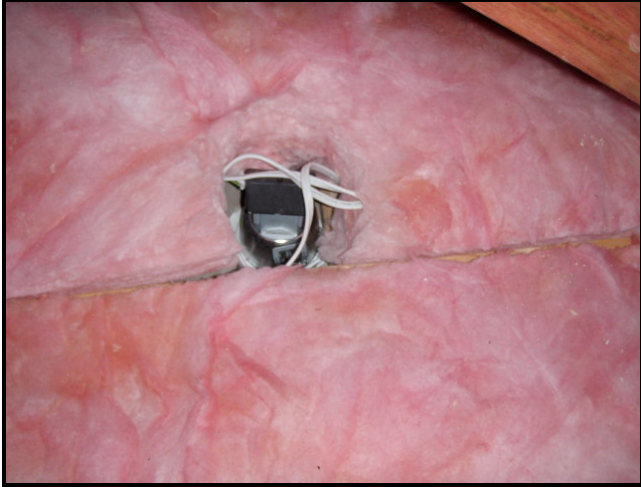
100mm clearance from downlights not achieved	
<p>The Auditors looked for whether the insulation material had been installed with a 100 mm clearance from recessed downlights, unless there was information to advise otherwise. It was found that of 17 audits with downlights installed, 15 audits (88%) found insulation within 100mm of the downlights. Of those, 87% were rated as medium to major.</p> <p>In 2 audits, documentation was provided to show insulation could be butted to the downlight.</p>

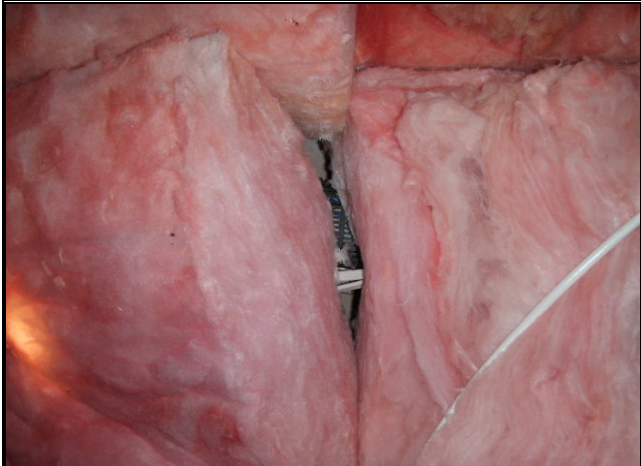
Auxiliary equipment covered	
<p>The Auditors looked for whether the insulation material had been installed over auxiliary equipment. It was found that of 8 audits with auxiliary equipment installed, 4 audits (50%) found auxiliary equipment to be covered with insulation. Of those, 100% were rated as major.</p>

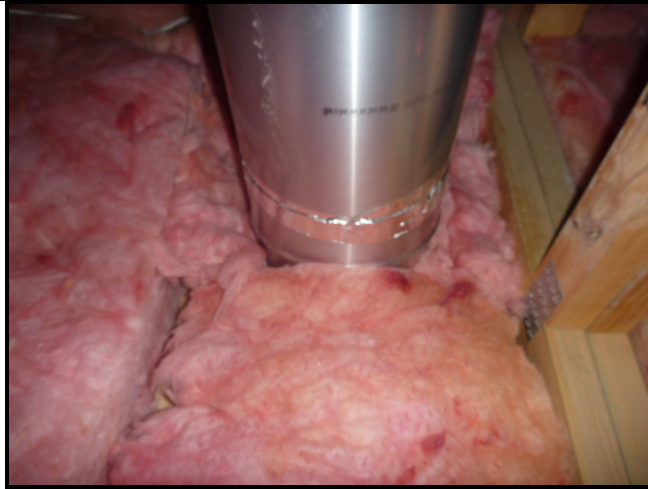
150 mm from extractor fans, metal chimneys and flues

The Auditors looked for whether the insulation material had been installed with a 150 mm clearance from extractor fans, metal chimneys and flues. It was found that of 15 audits with one or more of these installed, **9 audits (60%) failed to achieve the required clearance.** Of those, **89% were rated as medium to major.**

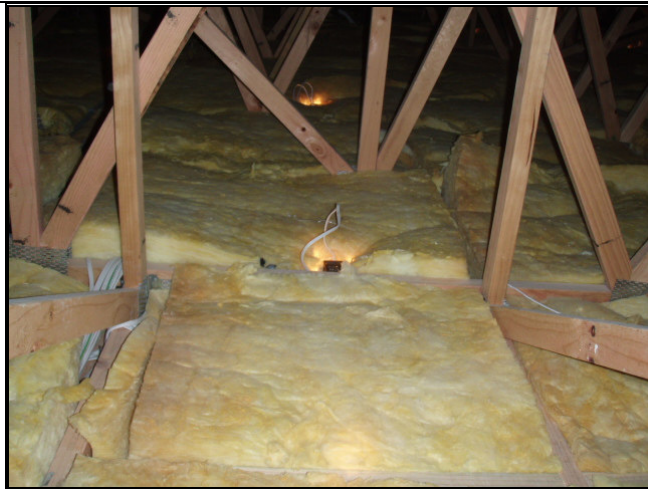
Electrical cables covered by insulation

The Auditors looked for whether the insulation material had been installed over electrical cables. It was found that **93% of ceiling installations had electrical cables covered by insulation.** Of those defects, **74% were rated as medium to major.**
